Home Inspection Report

123 Main St.

Upstate, SC 29XXX

Report #58XXXG

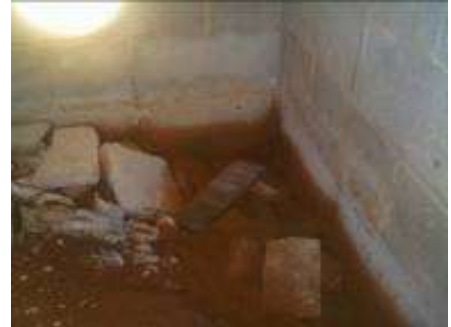
MINOR REPAIR: Wet stains on the foundation and wet earth indicate water has accumulated in the crawlspace. No signs seen to indicate the standing water has caused a humidity problem. The framing did not have abnormal stains and the moisture content was normal. Recently some termite companies have been requiring French type drains when there is any water present in order to issue a clear termite/moisture control letter. If the termite inspection is performed after a rain there could be some standing water and a French drain may be required. This could happen now or when you sell the house. Typical and inexpensive ways of reducing water entry are installing drain extensions on the gutter downspouts, creating a positive drain at the low area(s) and/or installing a sump pump. Consult a moisture control company for recommendations for how to reduce and control moisture.

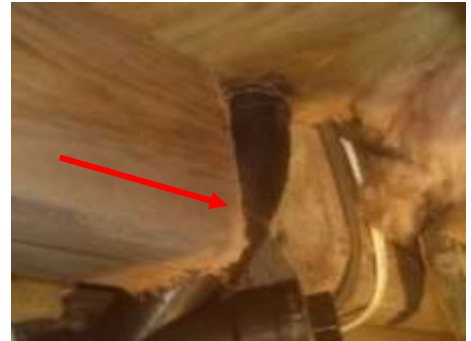
MINOR REPAIR: The double floor joists under the wall has been cut in two near the fireplace area. See photo.

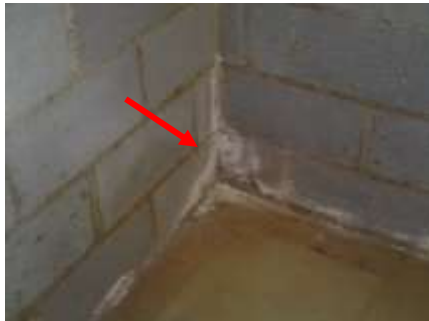
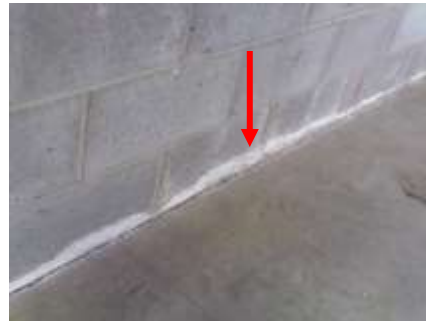
INVESTIGATE FURTHER: Efflorescence was seen in several areas on the foundation walls in the front right and left end unfinished areas of the basement. See photo's for examples. This is a white, fuzzy or powdery, migrated lime salt that indicates moisture has moved through masonry work. Consult the Seller's Disclosure Statement for details about dryness/dampness of these areas.

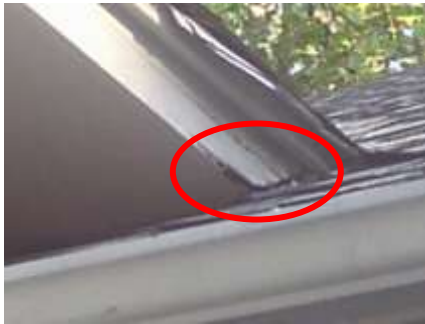
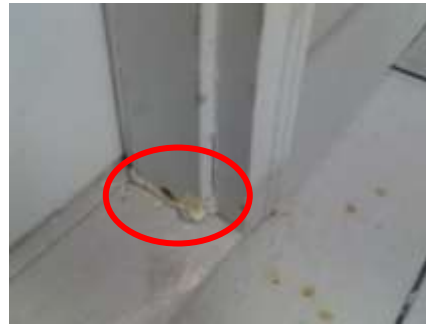
MINOR REPAIR: Damaged wood was observed in a few areas. These include, but are not necessarily limited to: boxing at front right of garage where it meets the roofline; lower casing/trim at side entry door into garage. See examples in photos. Some of the probed areas may be more obvious now. Concealed damage may be revealed during repairs.

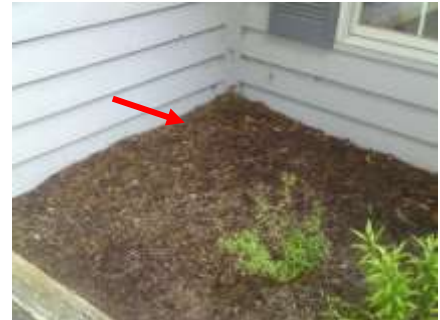
NOMINAL REPAIR: Some of the siding on the rear of the house is in contact with soil or mulch. See photo. The condition makes the siding/wall framing more susceptible to damage. Steps should be taken to eliminate earth and siding contact.

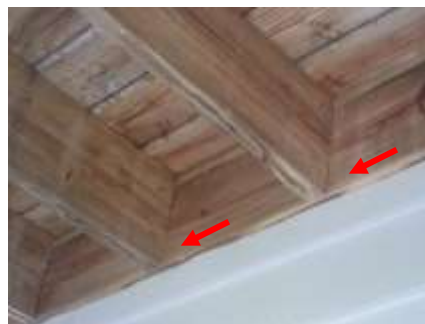
INVESTIGATE FURTHER: There are no ledger boards or joist hangers for the floor joist of the rear deck/porch to rest on where they are connected to the headers. See photo. No problems were seen at inspection; however, the areas should be monitored, and if the floor joists start to pull, repairs should be made.

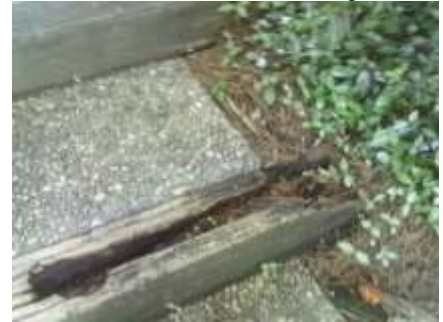
- The asphalt drive has typical cracking. The drive is serviceable and should be for some time. Seal coating helps reduce deterioration from water penetrating in cracks. Herbicides can be used at the edges so grass will not grow into the asphalt so readily.
- The driveway drain was not tested for functional flow. It should be flushed out periodically to determine if open and where water is discharging.
- The wood retaining wall along the front of the property and the wood in the right side walk was noted to be deteriorated in areas. See photo for example. Repairs do not appear to be essential at this time. However, repairs will be needed at some point in the future.

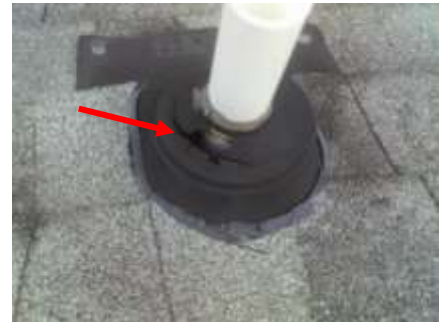
MINOR REPAIR: The flashing/rubber boots around the sewer vent pipes are cracked where the pipes extend through the boots, which typically allows for leakage.

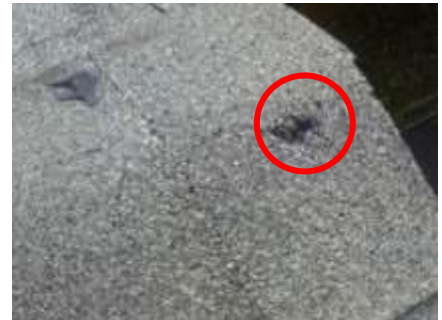
NOMINAL REPAIR: There are several exposed roofing nail heads around the roof which need to be sealed/resealed (mainly on the various flashings and in areas along the ridges).

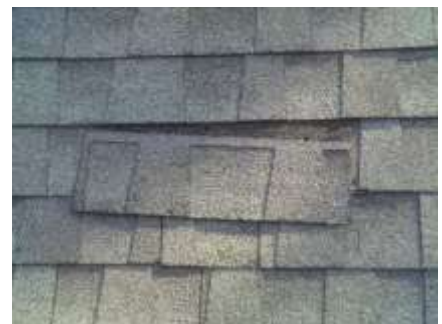
NOMINAL REPAIR: There is a loose shingle between the front right skylights. See photo.

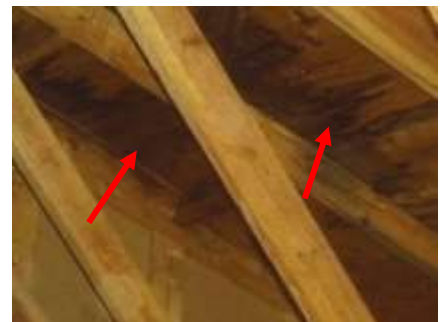
- There is a large stain on the roof decking below the cupola over the garage. See photo. This stain tested dry at the inspection with a moisture meter. Per the disclosure, there was a leak here in the past which has already been repaired. Monitor for leakage in the future.

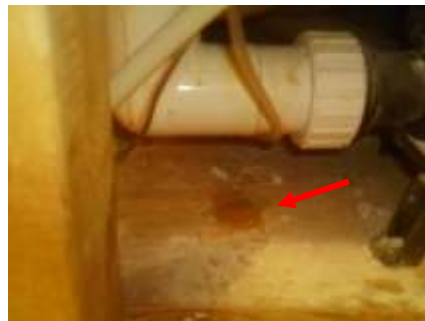
MINOR REPAIR: There is a slow leak in a supply pipe above where the far left end water heater is installed (note wet stain on the floor here).

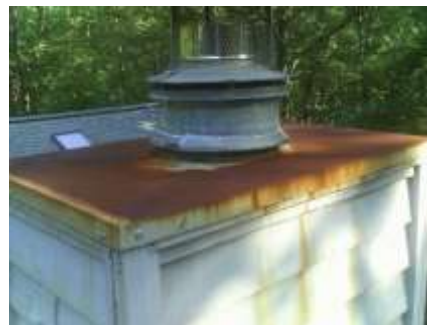
MINOR REPAIR: Surface rust has formed on the metal cap at the top of the chimney. See photo. This should be controlled to prevent rust through.

MINOR REPAIR: Some soot and/or creosote build-up was seen inside the rear metal flue.
